# **Exhibit H**

**SUBJECT:** Ice room or ice maker frozen or leaking, fan noise from ice room

SERVICE BULLETIN	
<b>Product:</b>	<b>French Door Refrigerators</b>
<b>Bulletin Date:</b>	<b>07/17/2015</b>
<b>Bulletin Number</b>	<b>ASC20150717001</b>
<b>Models:</b>	RF23HCEDB, RF23HCEDT, RF23HSESB, RF23HTEDB, RF23J9011, RF24FSEDB, RF25HMEDB, RF263BEAE, RF263TEAE, RF26J7500, RF28HDEDB, RF28HDEDT, RF28HFEDB, RF28HFEDT, RF28HFPDB, RF30HDEDT, RF31FMEDB, RF31FMESB, RF323TEDB, RF32FMQDB, RF34H9950, RF34H9960, ALL COLORS

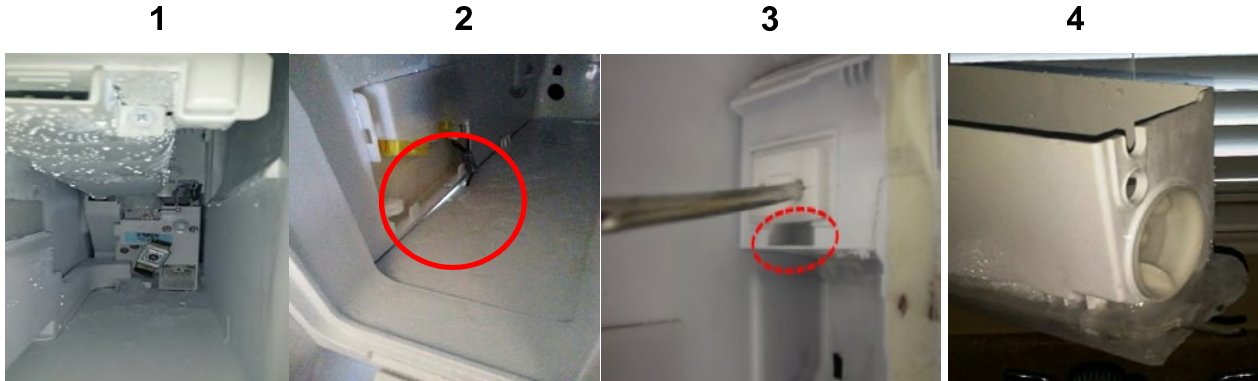
**Customer Complaint:** One or more of the following symptoms

1. Ice crystals and water droplets form at the bottom of the ice maker. Slushy Ice
2. Water under the crispers or running down the left side wall due to a gap in the ice room.
3. Fan noise that stops when FF door is opened due to ice in ice room fan duct.
4. The ice bucket is stuck and will not come out (possible clogged drain)
